DOE/NV--1191

Post-Closure Inspection Report for
Corrective Action Unit 92:
Area 6 Decon Pond Facility,
Nevada Test Site, Nevada
For Calendar Year 2006

March 2007

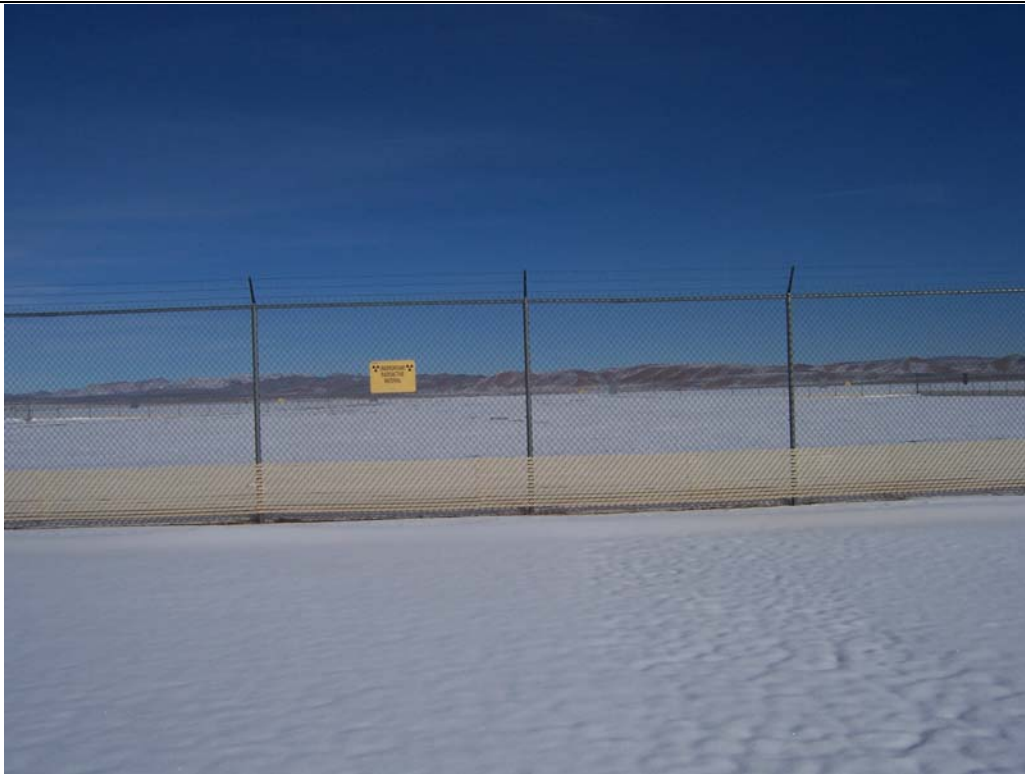
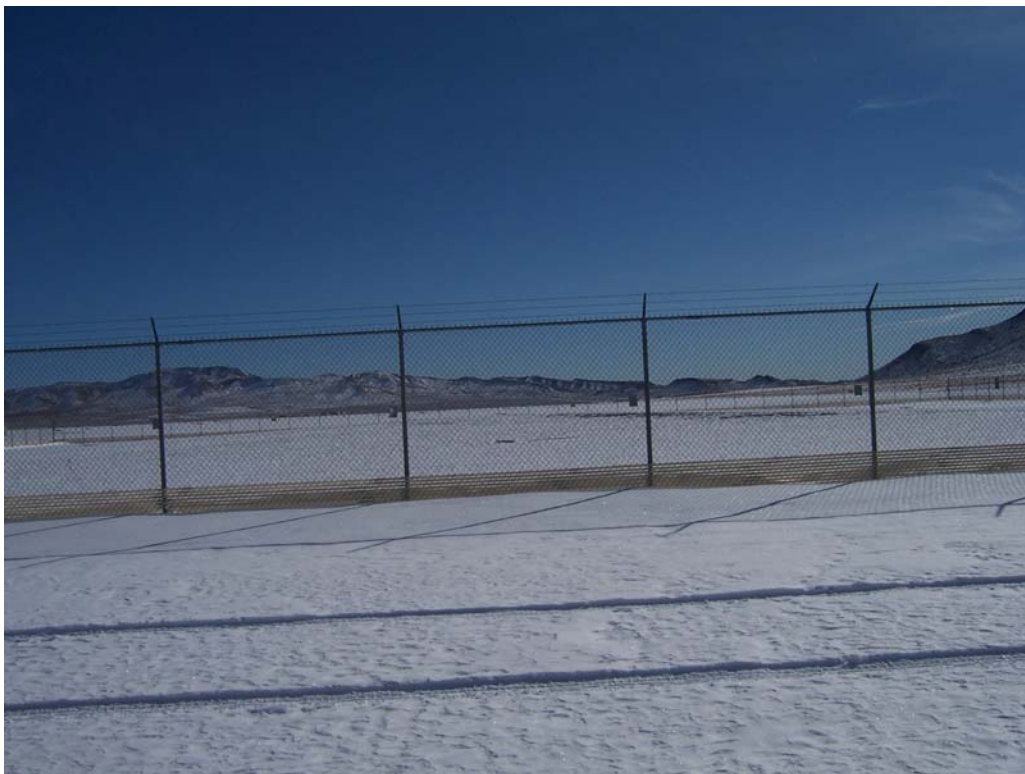
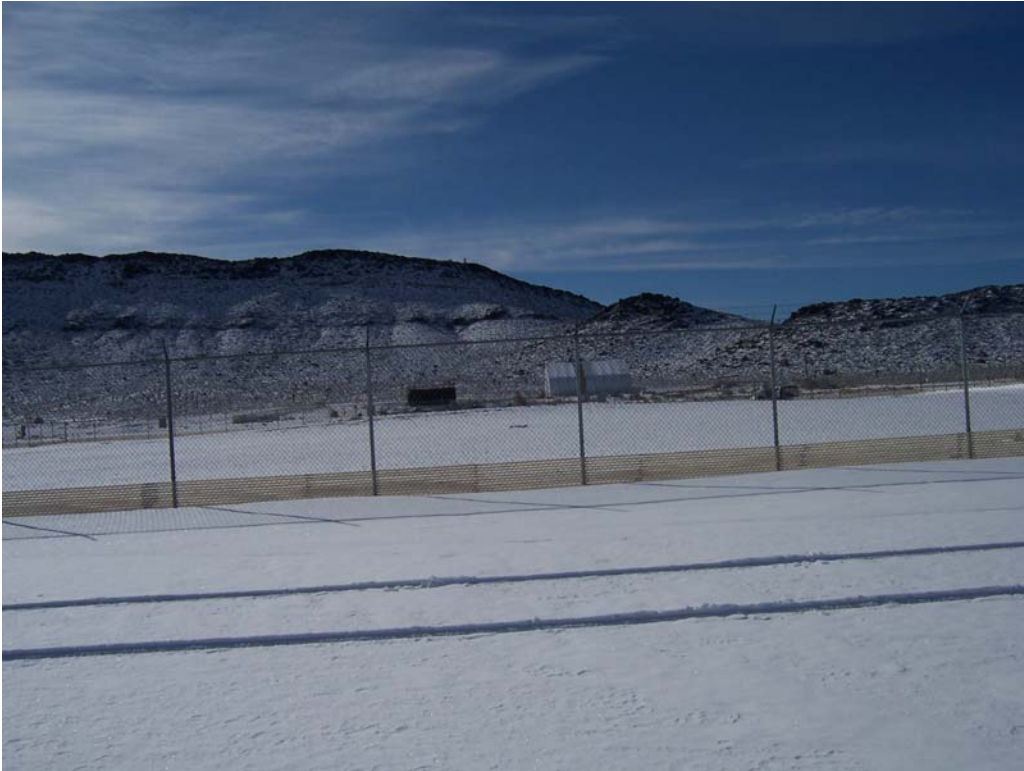
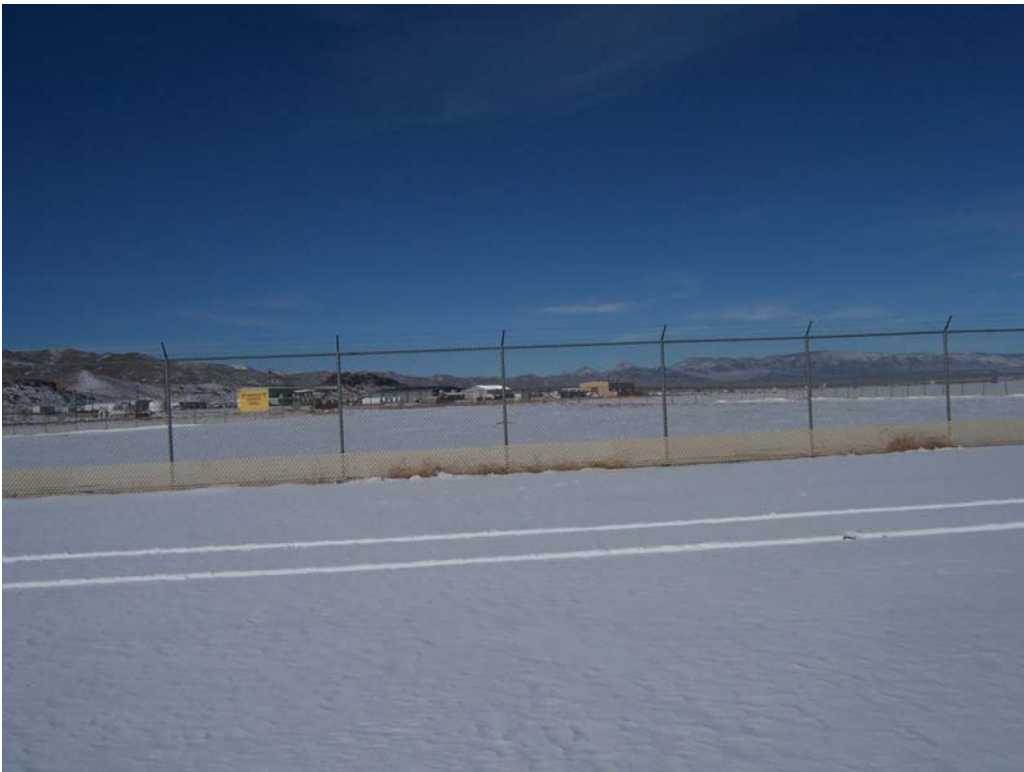
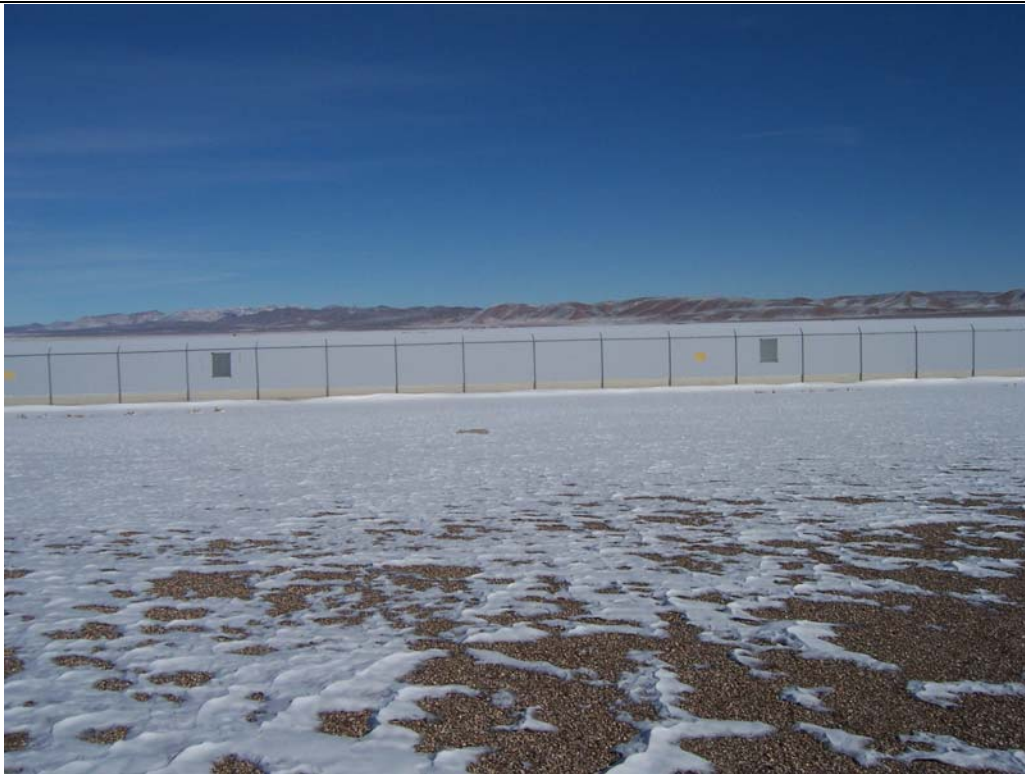
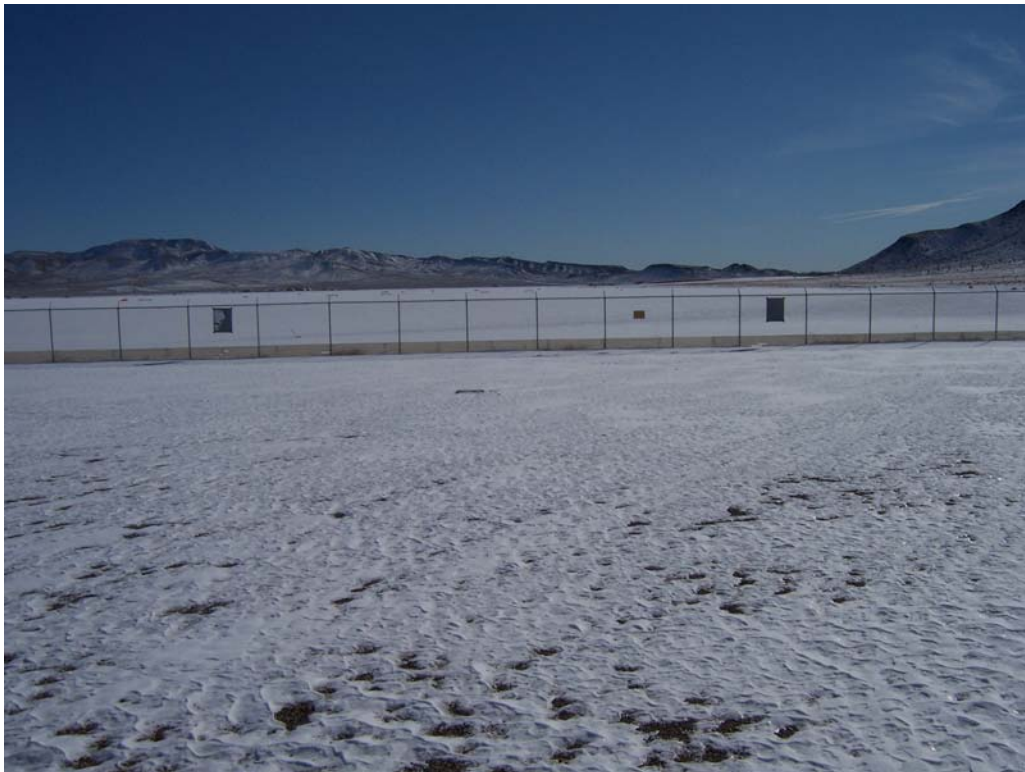
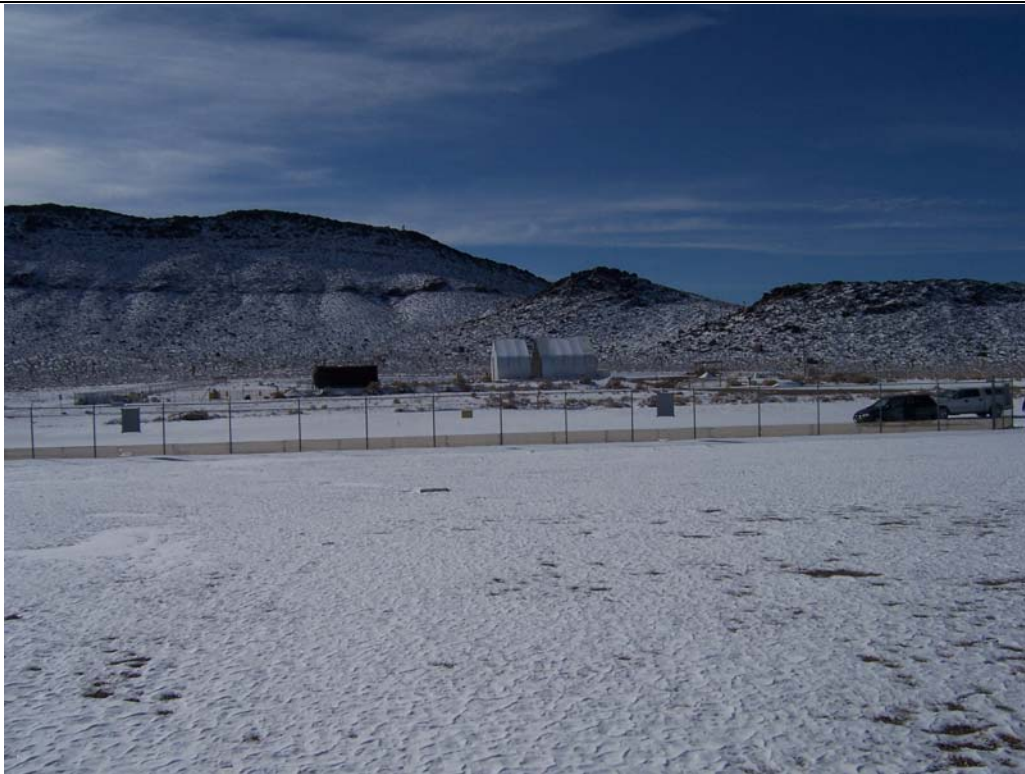
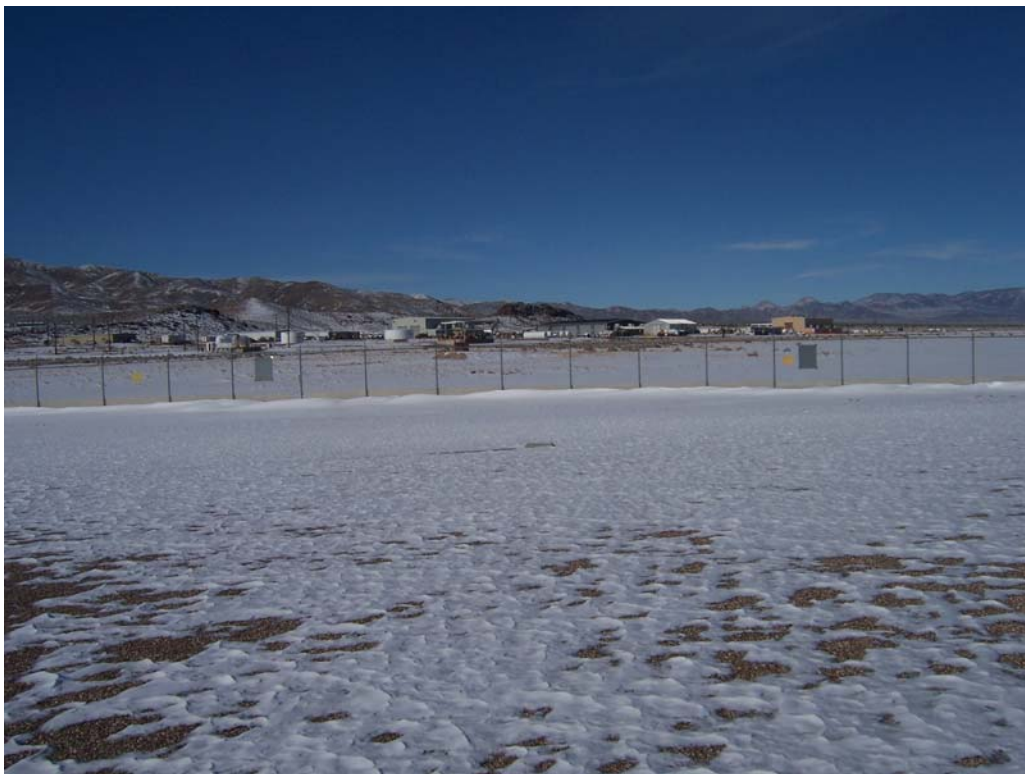
The fourth quarter inspection was conducted on December 20, 2006. The inspection indicated that the unit was in excellent condition. The wave barrier was damaged due to high winds, and maintenance was recommended. No other issues were identified with the fence, signs, monuments, or cover.

All observations indicated the continued integrity of the unit; however, it was recommended to repair the wave barrier.
